Head Gasket Change - Lotus Elan M100

The current problems

- i. Continual loss of cooling water. Required coolant top-up two/three times per week.
- ii. Oil in cooling water
- iii. Oil leaks on front and side of engine.

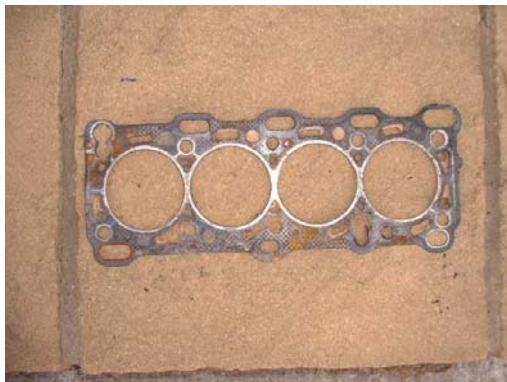
Figure 1

- iv. When the head was being lifted off, the head gasket came away very easily from both the block and the head. Fig 1 (gasket bottom side) and fig 2 (gasket top side) show the two faces of the gasket. They show that there was no visible damage to the seals around any of the bores, but there was damage to several oil and waterway holes. The gasket had deteriorated very badly with substantial fretting to the surfaces on both sides. A thin amount of gasket had been left on most of the surface of both the block and head, which had to be carefully scraped off to ensure that the two mating faces were not contaminated in any way when reassembled. There was evidence of leaks tracking across the gasket, including between oil and waterways, and outwards to the edge of the gasket. The raised parts of the gasket, around each of the holes used to seal the holes, had all been flattened (to be expected) but some of them had actually fractured around holes, and were not sealing properly. Fig 3 shows complete loss of gasket material between two adjacent holes. Fig 4 shows blackening of the gasket around the oil hole situated in the corner of the block underneath the CAS sensor. The gasket had completely delaminated in this area. It had become porous to oil and had consequently discoloured very badly. Fig 5 shows complete failure of a seal around a gasket hole. I couldn't find any of the missing pieces of gasket, so presume they had disappeared into the water and oil systems somewhere !!
